ARE YOU IN THE "NO ZONE"?

"Share the Road"

Missouri Department of Transportation's

Linn State Technical College Summer Transportation Institute

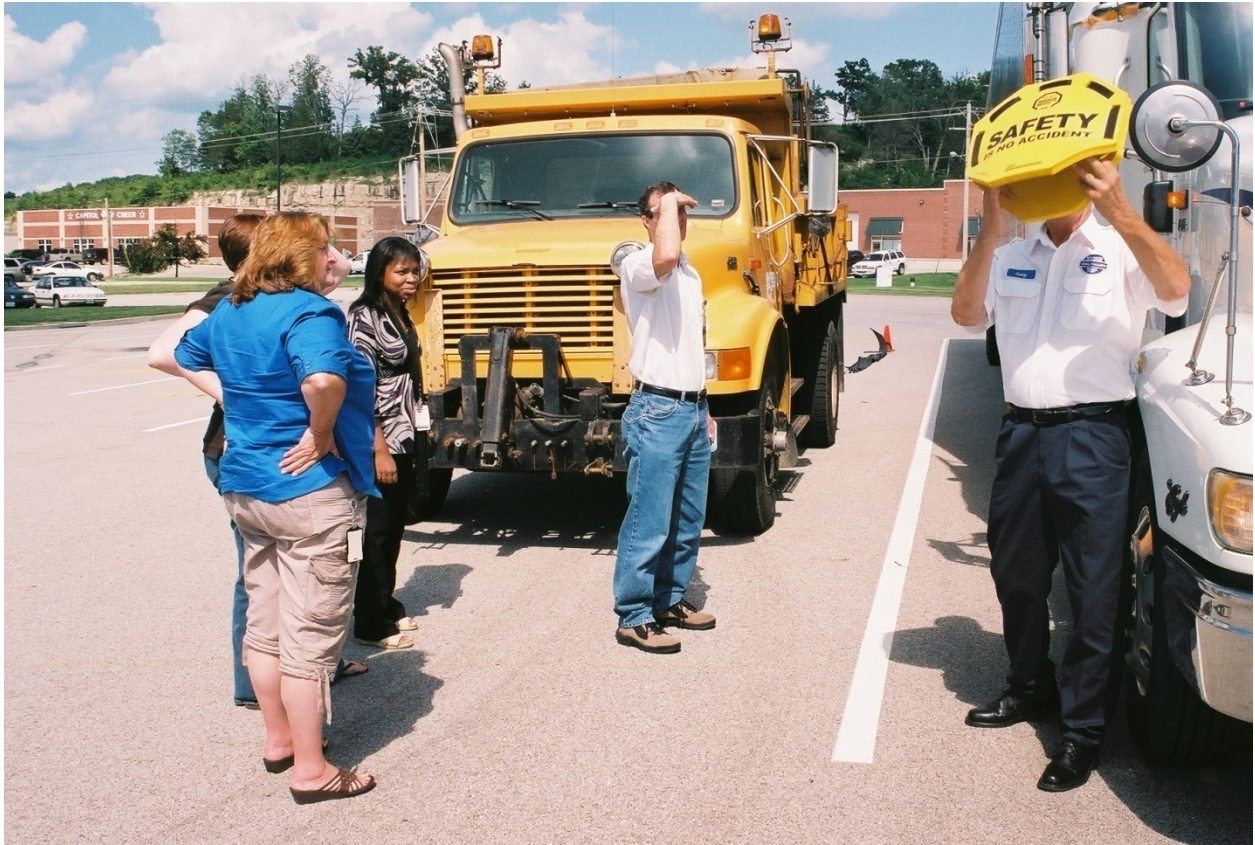
Gary Leu showed some of the participants the additional mirrors that Wal-Mart has mounted on all their trucks to help the drivers with the right side blind spot. The right side of a commercial vehicle has the largest "NO Zone" area. These mirrors help the driver by providing him with the ability to see vehicles that could be in that area around the vehicle. Notice the Missouri Department of Transportation Dump Truck that is parked on this side of the vehicle. Without the spot mirror the driver will not be able to see even that large vehicle.

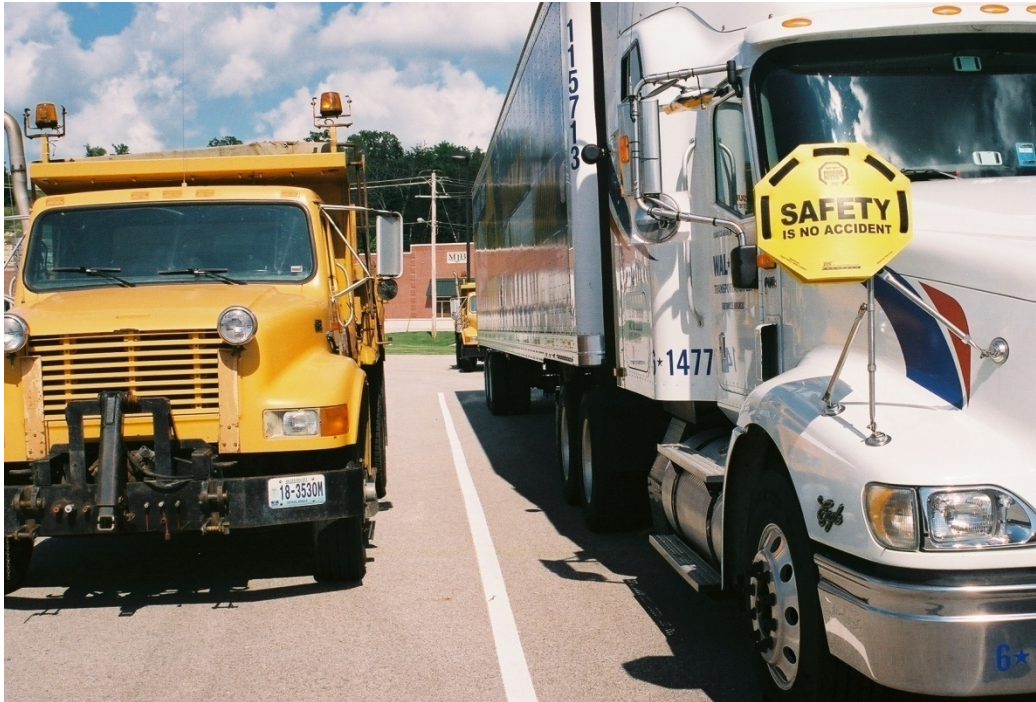
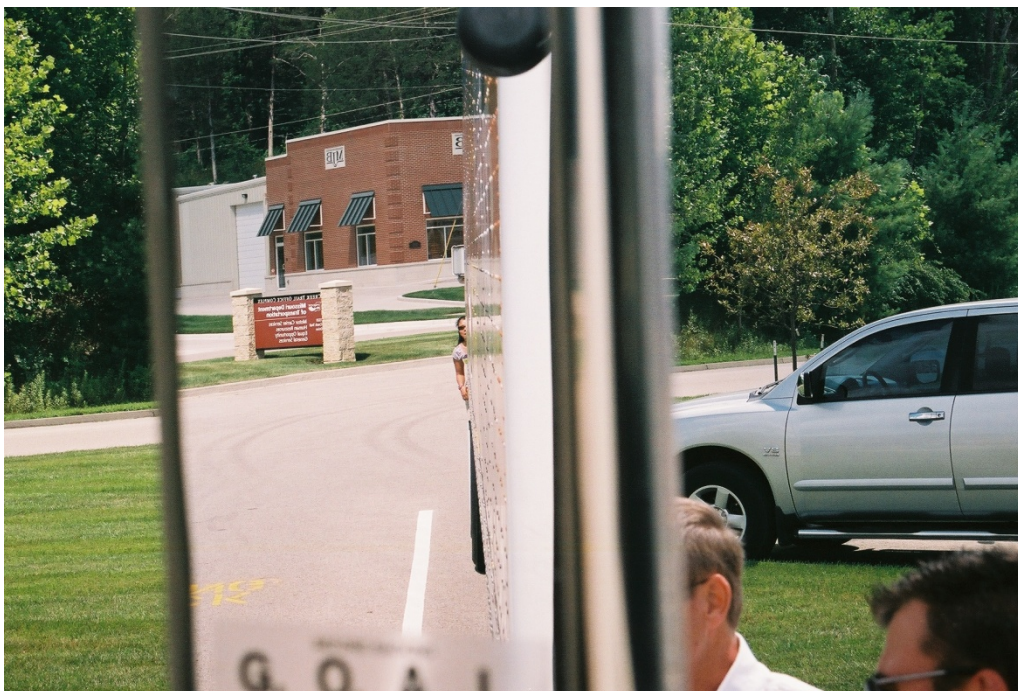
The group then moved to the rear of the vehicle where another MoDOT vehicle was parked. The vehicle is approximately 50 feet behind the truck and from this angle you can barely see the vehicle. The picture below is from inside the vehicle looking out the right side mirror. "Can you see me now?"

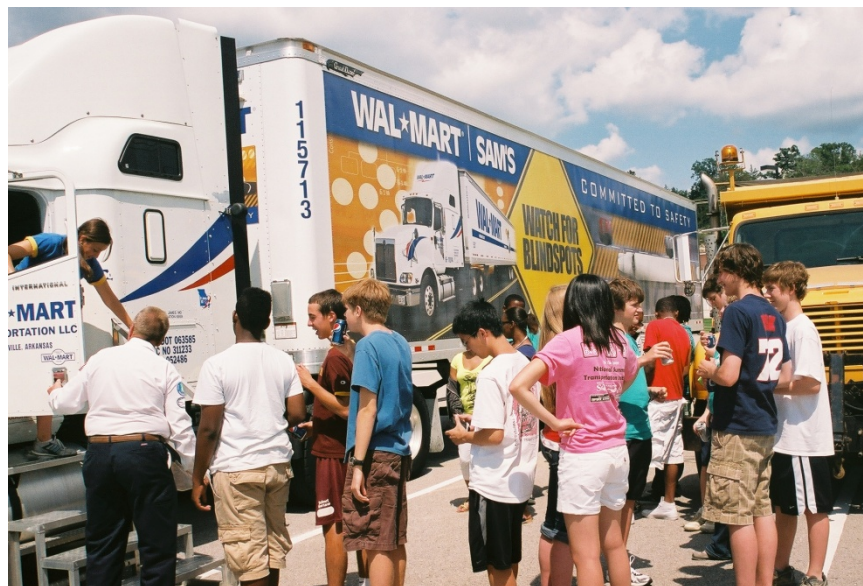
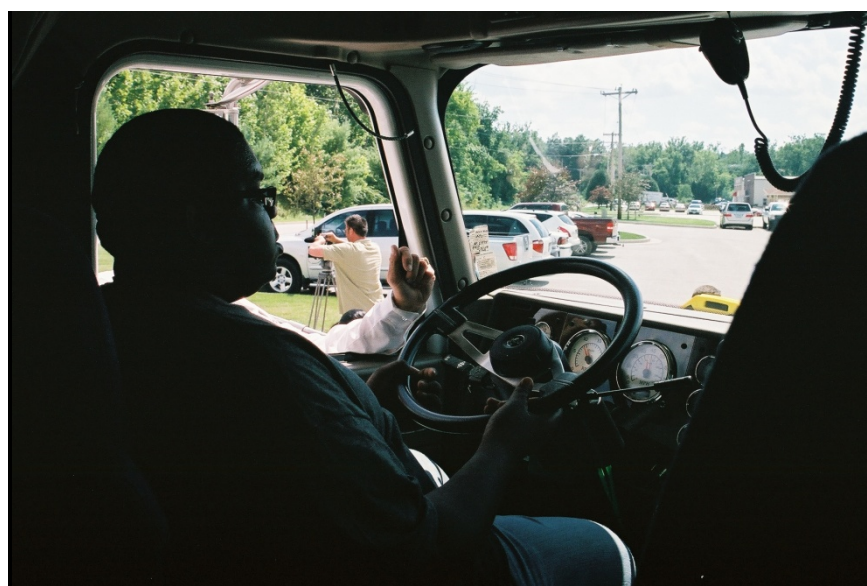
The attendees came forward on the left side where another MoDOT vehicle is staged in the left side blind spot. The left side blind spot is smaller than the blind spot on the right side of the vehicle because the driver is positioned behind the wheel on the left side of the vehicle. However, the area near the front of the trailer is a blind spot where the driver can not see a vehicle. As one of the attendees was exiting the vehicle, Darrell told the group to be sure that they can see the driver's eyes in the truck's mirror. If they can see the driver's eyes then the driver can see their vehicle.

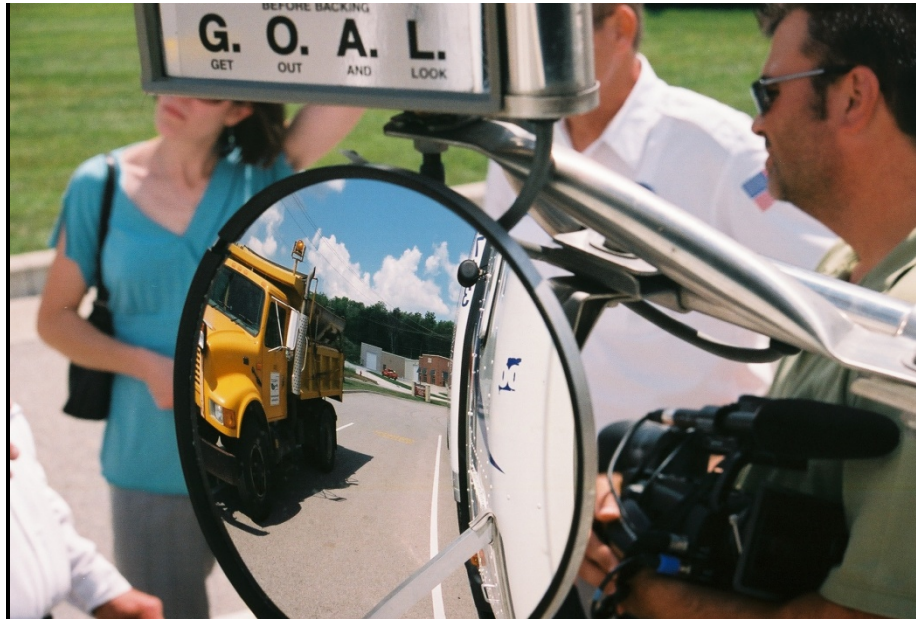
This picture, taken from the driver's seat, shows the left side spot mirror which helps the driver to see the vehicles in the left "No Zone" without that mirror the vehicle in the "No Zone" will disappear from view.

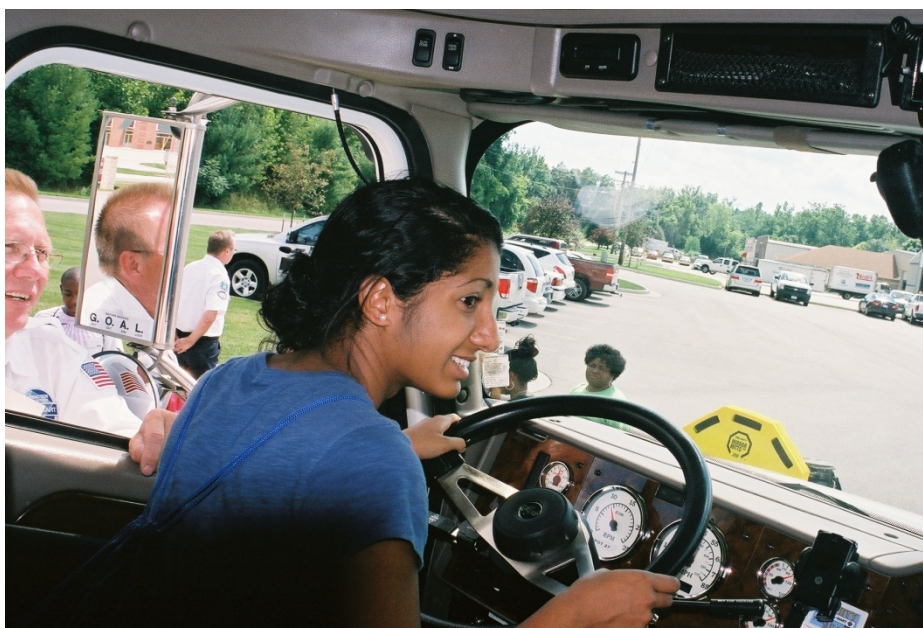
Next Darrell asks a young lady if she can see the vehicle on the right side, she shifts forward in the seat trying to see the vehicle without the benefit of the right side spot mirror. Darrell reminds her that with her seat belt fastened she could not move that far forward in order to see.

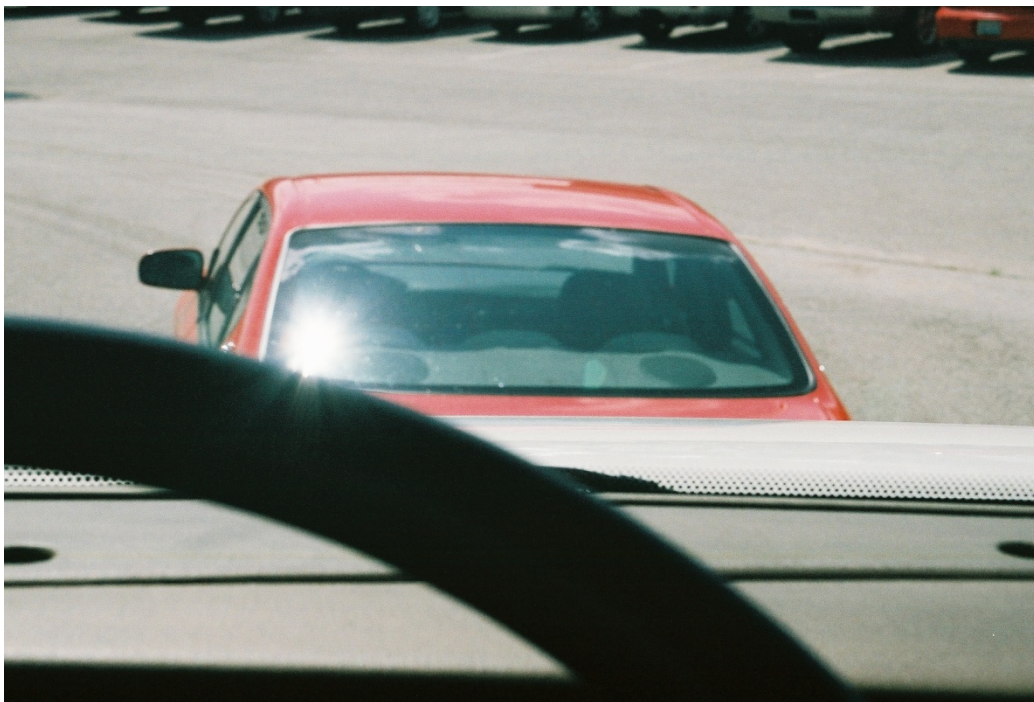
Can you see the cars turn signal and brakes lights in the photo below?
